**FIELD RECONNAISSANCE SAMPLING  
BURLINGTON HILL SITE  
BURLINGTON, SKAGIT COUNTY, WASHINGTON**

PREPARED BY:  
U.S. EPA Region 10  
Office of Environmental Assessment  
1200 6<sup>th</sup> Avenue, Suite 900  
OEA-095  
Seattle, WA 98101-3140

March 6, 2013

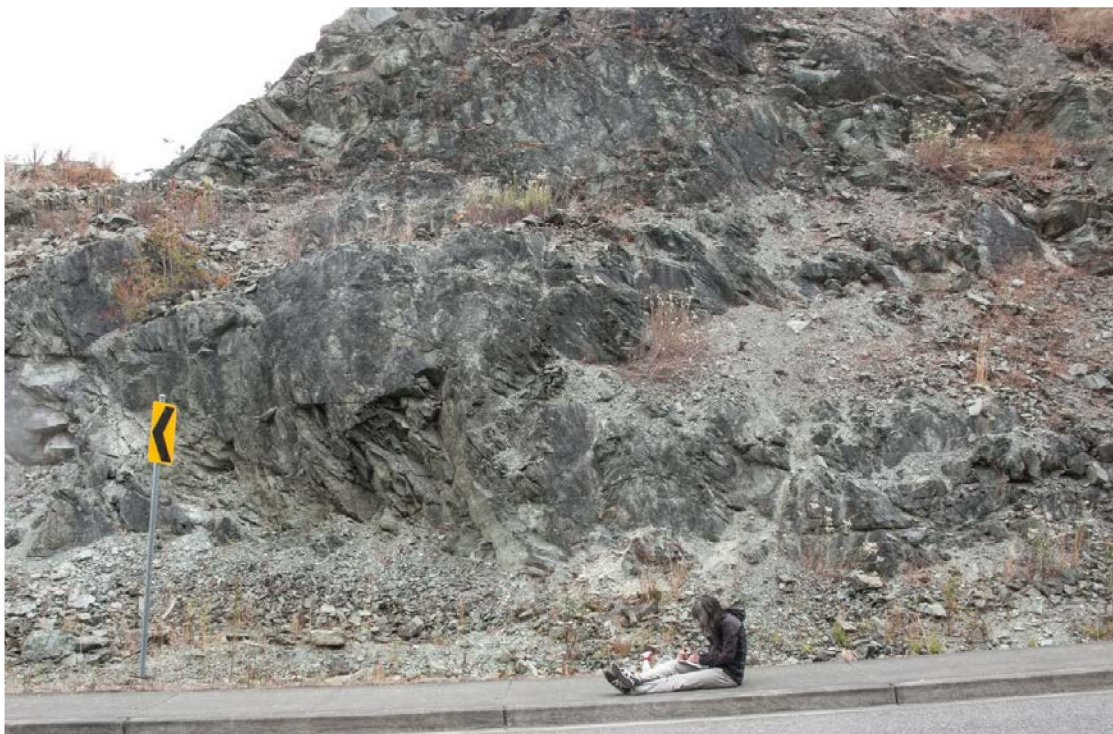
In response to the resident's concern, EPA mobilized for the site visit and focused on areas that could be easily accessed. Figure 1 shows locations where field observations were made by Lorraine Edmond and samples were collected by Julie Wroble. These locations consisted of two roadcuts, the resident's property, and the former quarry. Sample locations were determined based on ease of access and the presence of exposed rock (outcrops and road cuts). Samples were collected by breaking off fragments of exposed rock with a rock hammer, and placing the fragments into a sample jar for analysis by polarized light microscopy (PLM). For more in-depth results, larger samples of rock specimens were gathered that could be photographed using a
